Manhole Inspection Summary

Manhole # S43SS_020MH

Insp Date: **2/27/07 9:06 AM**

Location Address: **1646 MONTPELIER ST**

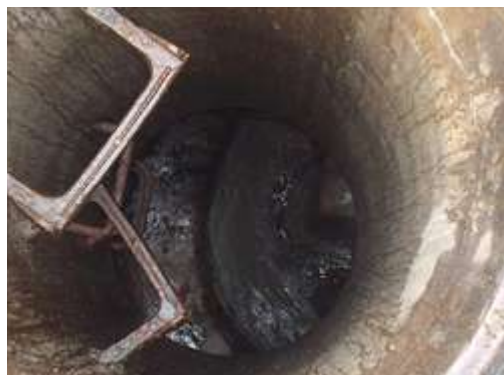
Top View

Frame leaks. Frame offset. Corroded steps. Adjustment infiltration.

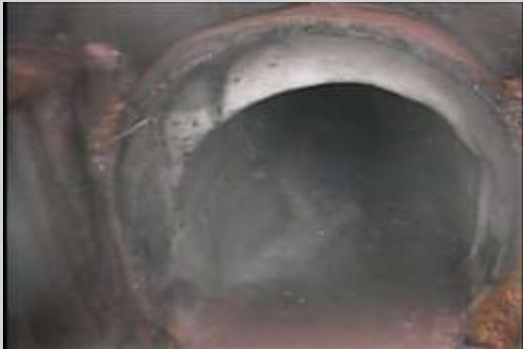
18 in. Circular Gravity Sewer Pipe Out @ 12 O'Clock

Infiltration: **Evidence** Pipe Seal Cond: **Unknown**

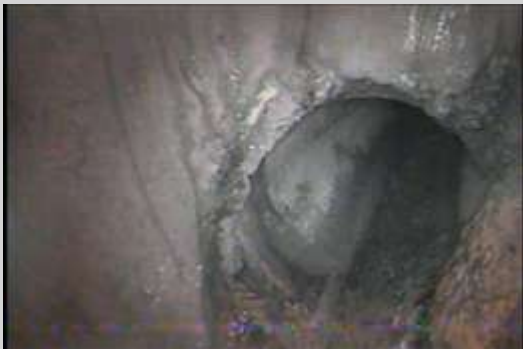
8 in. Circular Gravity Sewer Pipe In @ 3 O'Clock

Infiltration: **Evidence** Pipe Seal Cond: **Unknown**

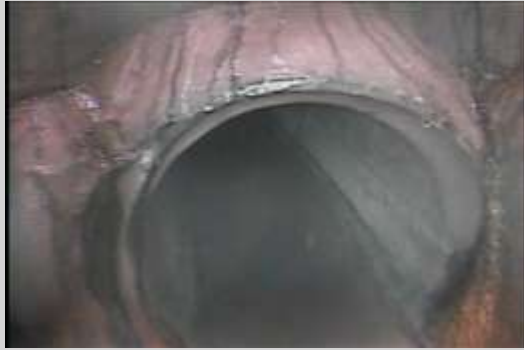
18 in. Circular Gravity Sewer

Infiltration: **None**
